Appendix G: Field Testing and Evaluation of WAVE/DSRC Communications Functionalities

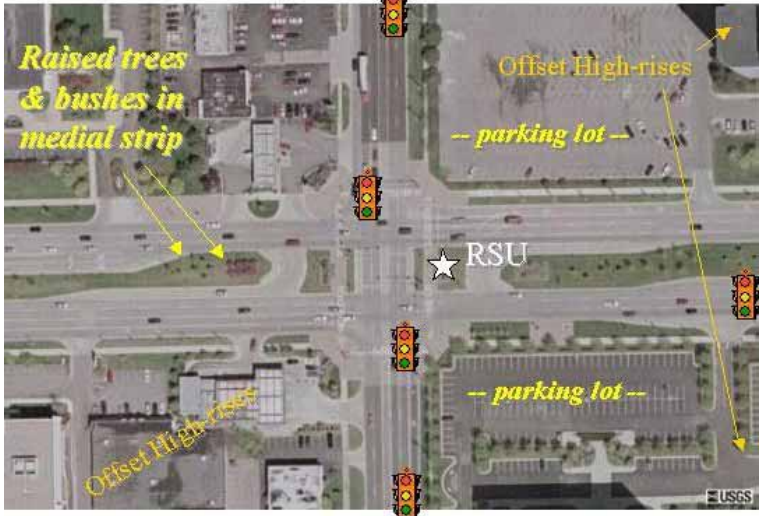
Table 1. Oakwood/Michigan and Crooks/Big Beaver Intersection

Crooks Road & Big Beaver Road Troy, MI	Urban area continually full of moving traffic during the daytime hours	3 lanes each way eastbound and westbound on Big Beaver Road, separated by medial strip Fewer lanes of traffic in the north and southbound directions on Crooks Road	Buildings nearby (a few with 10 floors or more), but the buildings are far removed by large parking lots Small trees and bushes on the media strip

This intersection has three lanes of traffic in the east and westbound directions, and these lanes are continually full of moving traffic during the daytime hours. The north and southbound directions on Crooks Road also have several lanes of traffic, but are not separated by the medial strip (with small trees and bushes) that is found on Big Beaver Road.

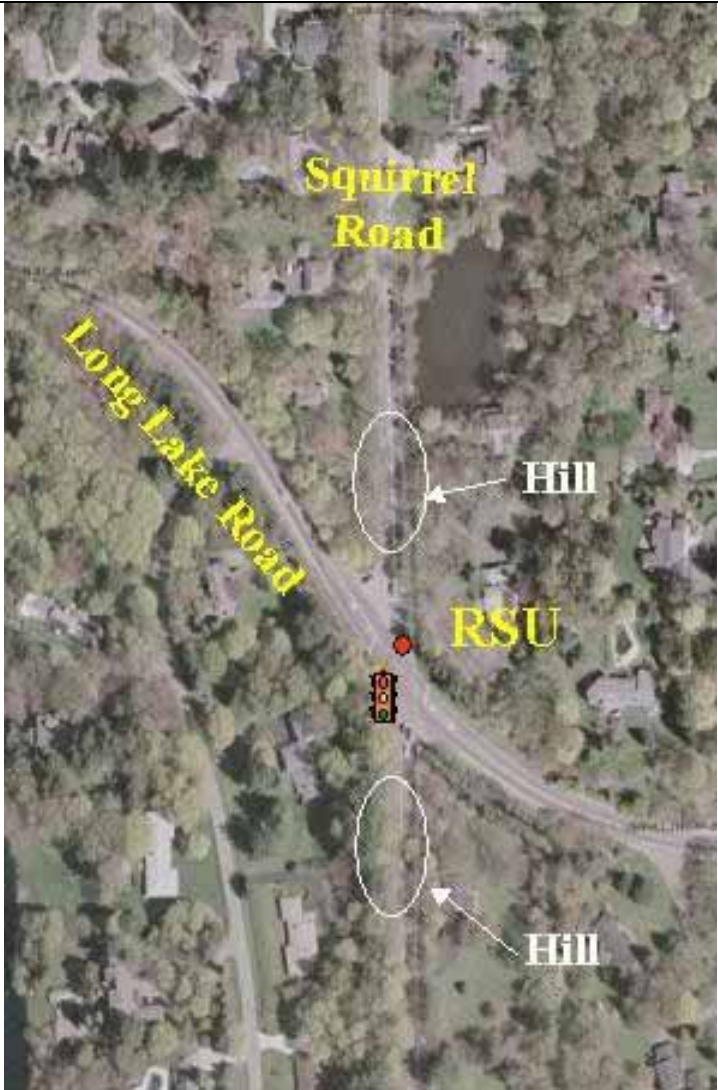
Table 8. Squirrel & Long Lake Intersection

Location	Setting/Traffic	Configuration	Obstructions	Illustration
Squirrel Road & Long Lake Road Bloomfield Hills, MI	Suburban area with light traffic during the time of the testing	1 lane in either direction for both roads, with left and right turn lanes at the intersection to accommodate the extreme curves of Long Lake Road	<p>Squirrel Road has overhead foliage, as well as hills, both of which descend in the southbound direction</p> <p>Long Lake Road has terrain and foliage along the curving roadway that eventually blocks the direct line of sight to the intersection</p>

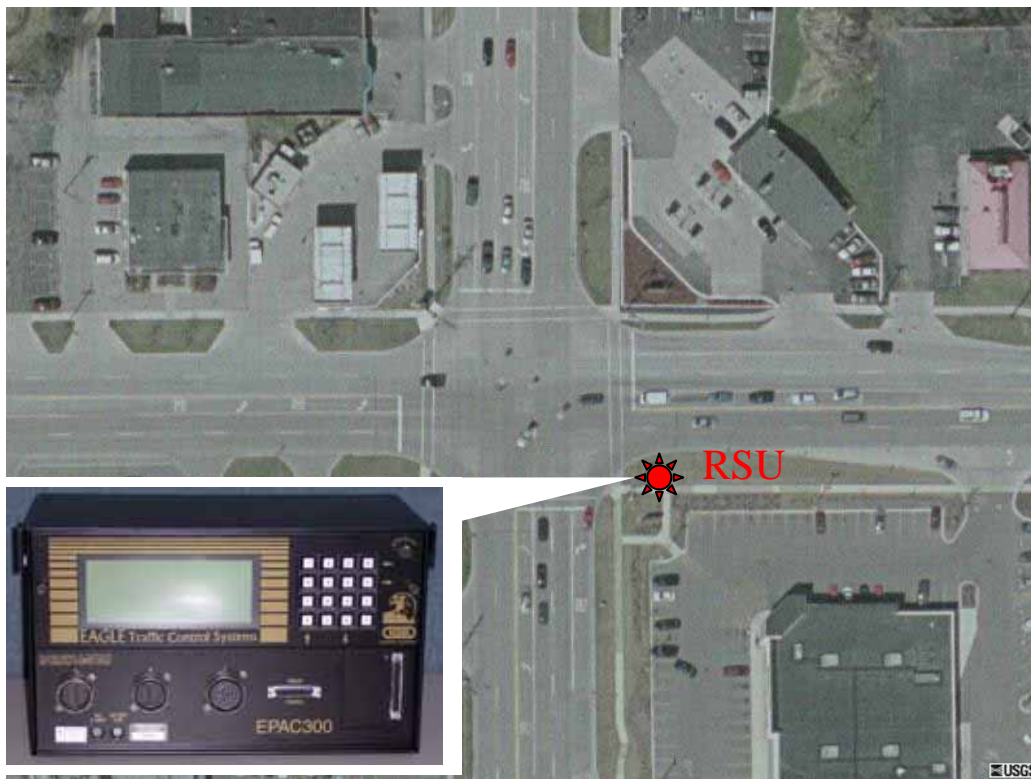
Figure 1. Controller Test Site at Orchard Lake Road and 10 Mile Road

The choice of which signalized intersection to run the tests could be based on factors such as the previous establishment of a cooperative atmosphere between the VSCC and the Road Commission of Oakland County (RCOC), and also the elimination of those locations where the dynamic control of the traffic lights changes the signal timing. Testing at such an intersection would add another dimension of complexity that was beyond the scope of this preliminary feasibility study. The intersection chosen for the test was Orchard Lake Road and 10 Mile Road in Farmington, Michigan (Figure 1). The traffic signal controller shown in the inset of Figure 1 was programmed by the RCOC to use exactly the same timing as the controller at the selected intersection.

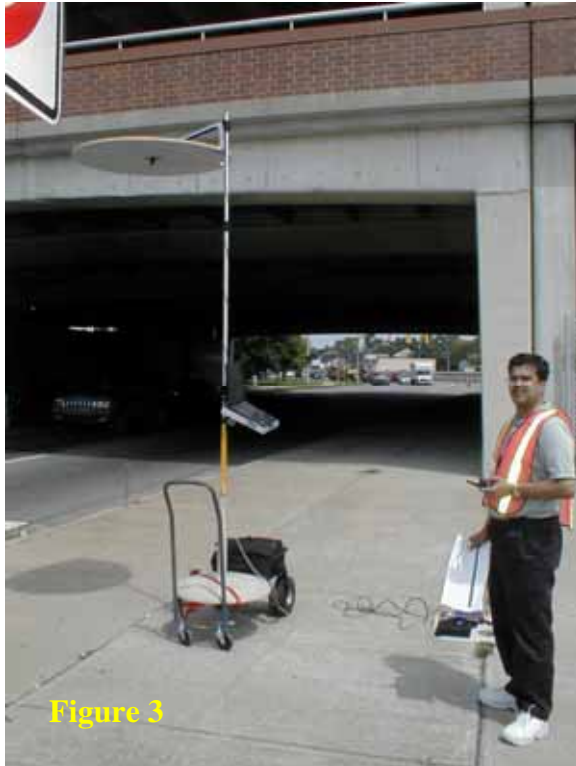
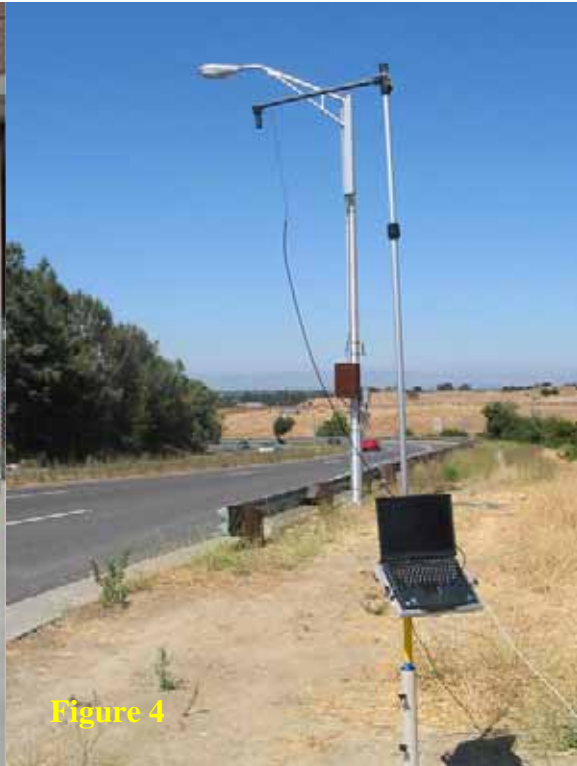
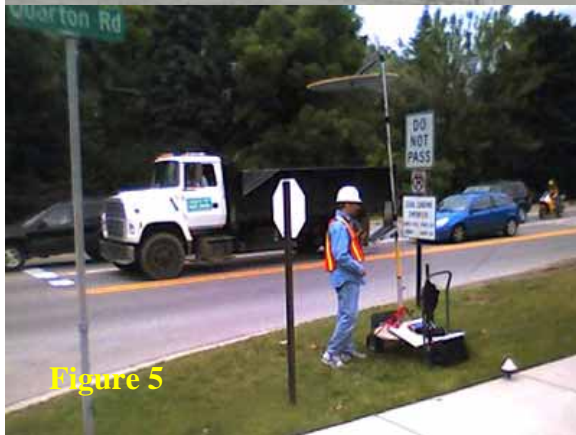
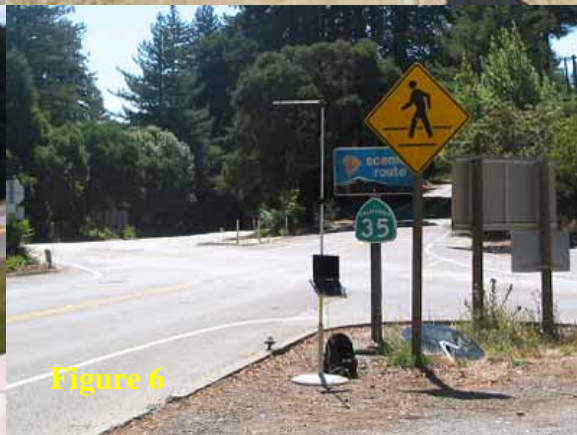
The Communication Test Kits (CTKs) from Task 4 were utilized to acquire the intersection testing data. The laptop computer, running the latest version of test software under Linux (V3.0.4), was mounted on a platform attached to the telescoping poles so that signal losses in the cables to the antennas would be minimized. The GPS antenna was placed nearby on the ground, typically in a position where interference from various objects (antenna ground plane, intersection features, test personnel, etc.) would be minimized. As such, there is often a minor

offset of a few meters between the actual RSU broadcast location and the recorded GPS coordinates. Also visible in the following figures is a portable battery pack, which was used to power the GPS receiver unit.

Figure 3. RSU at Detroit Area Test Location
Figure 4. RSU at Palo Alto Area Test Location
Figure 5. RSU at Detroit Area Test Location
Figure 6. RSU at Palo Alto Area Test Location

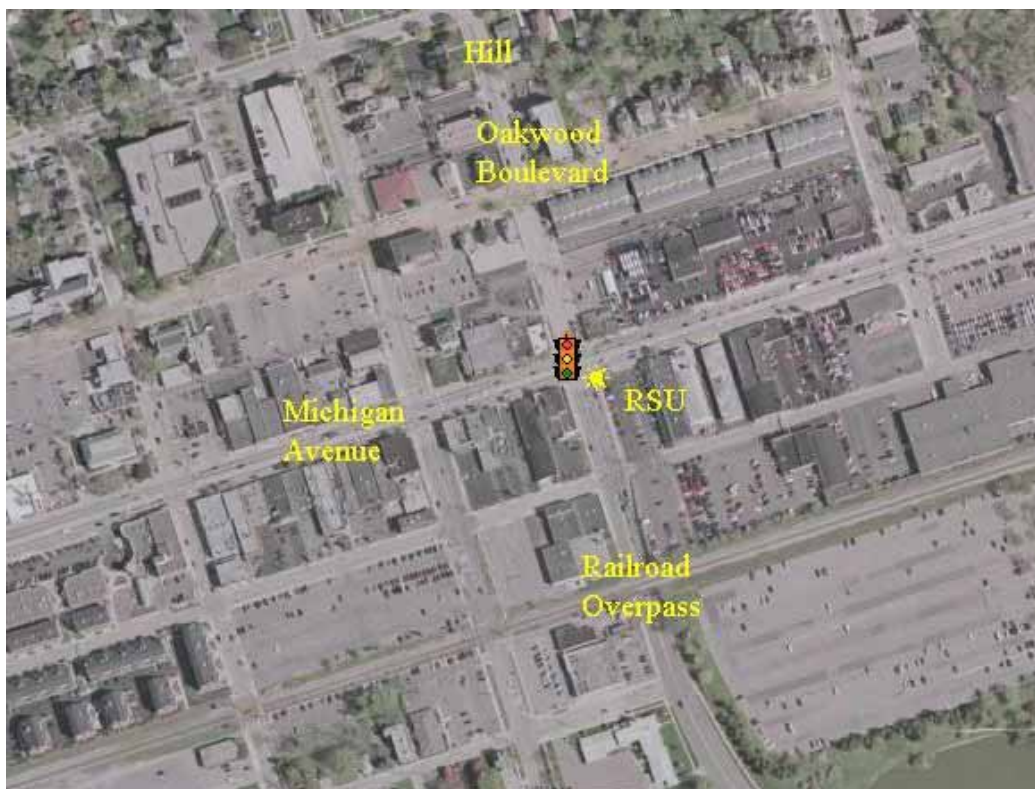
Figure 8. Aerial View of the Oakwood/Michigan Intersection

Five lanes extend out from this signalized intersection in each of four directions, and the intersection normally experiences heavy daytime traffic. For all of the data acquired, the RSU remained positioned on the southeast corner of the intersection, from which reasonable line of sight was provided in each direction of traffic (Figure 8).

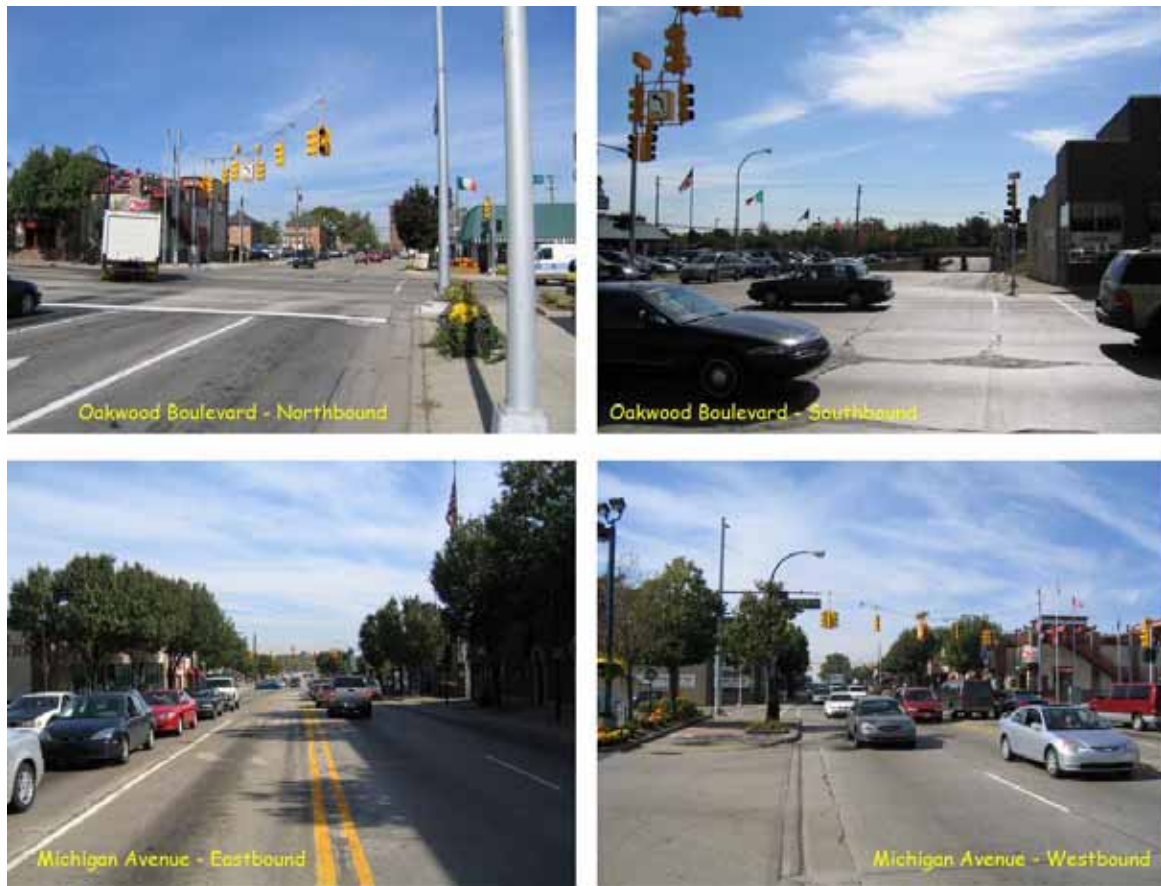
Figure 10. Views from the Oakwood/Michigan Intersection

Proceeding northbound on Oakwood Boulevard in medium density traffic, only 3 packets were dropped at distances to the RSU less than 100m. While reception on the northbound side was entirely consistent with the apparent line of sight to the hillcrest, considerable reception was obtained on the southbound side well beyond line of sight, despite the drop in elevation to pass under the railroad tracks and the subsequent bend present in the road. Clearly, there were reflected signals present due to the physical structures involved. Note that although the GPS signal was lost under the railroad overpass, radio data was still being acquired. Reversing the direction and driving southbound produced similar results, with only 4 packets lost within ~100m of the intersection (Figure 10).

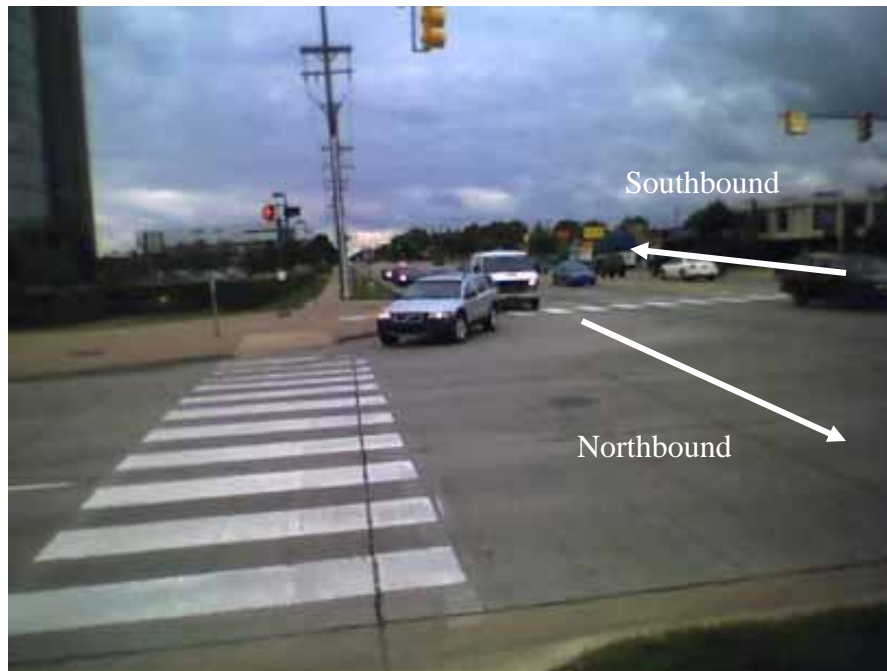
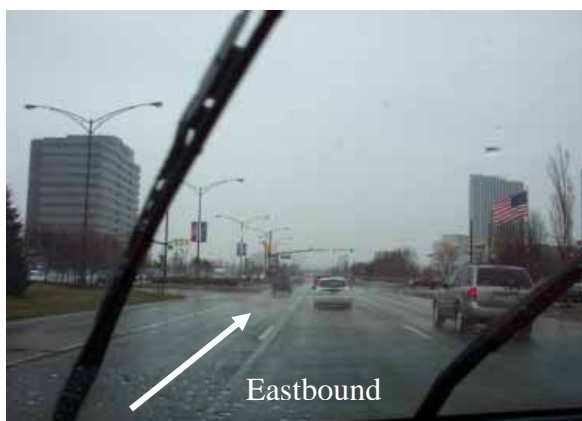
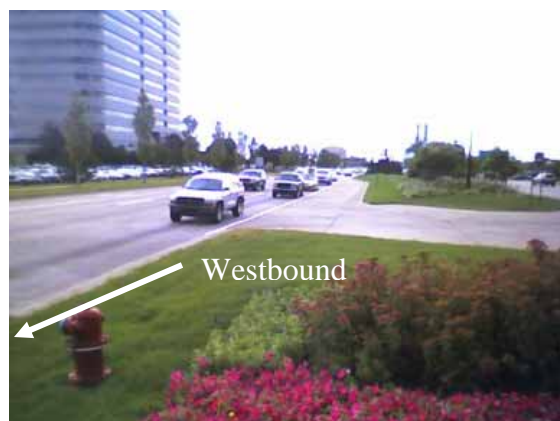
Figure 13. Views of the Crooks/Big Beaver Intersection

In the other directions of travel (Figure 13), line-of-sight interference caused a low RSSI at a significant distance from the intersection. Yet most of the packets were still received, as shown by callouts in Figure 14. The packets dropped in (2) would not be a concern since the vehicle had already proceeded through the intersection.

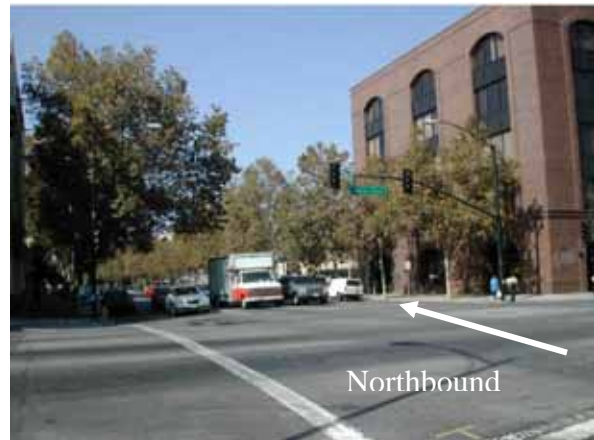
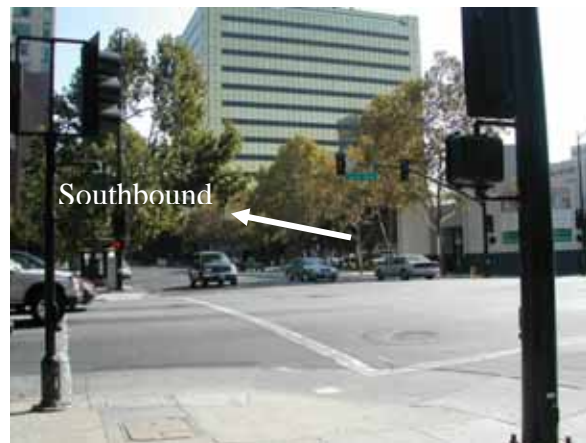
Figure 16. RSSI Plot and Views of Market/Santa Clara Intersection

The intersection of Santa Clara and Market has closely packed high rises all around. The test car started off near the RSU (intersection) and traveled north onto Market (Figures 16 and 17). It turned back at St. John and passed the RSU. Then it turned back again at San Carlos and returned to the RSU.

Packets were dropped frequently along the test route due to heavy traffic and no line-of-sight between the RSU and the OBU. One possible method to improve the packet reception at this type of intersection would be to position the RSU at a higher height to improve the line-of-sight between the sending and receiving antennas.

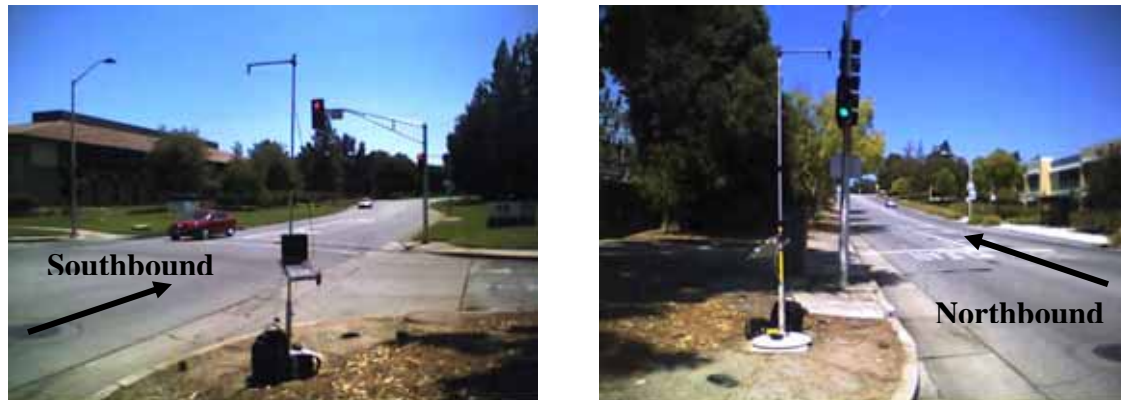
Figure 19. Views of the Hillview/Hanover Intersection

The test car started off from the RSU onto southbound Hanover (Figures 19 and 20). It turned back after the curve, then passed through the intersection. It continued and went slightly uphill on northbound Hanover. It finally turned back ~300m away from the intersection and returned to the RSU. Occasionally the hill or objects and terrain along the edge of the curving Hanover Road obscured the line-of-sight.

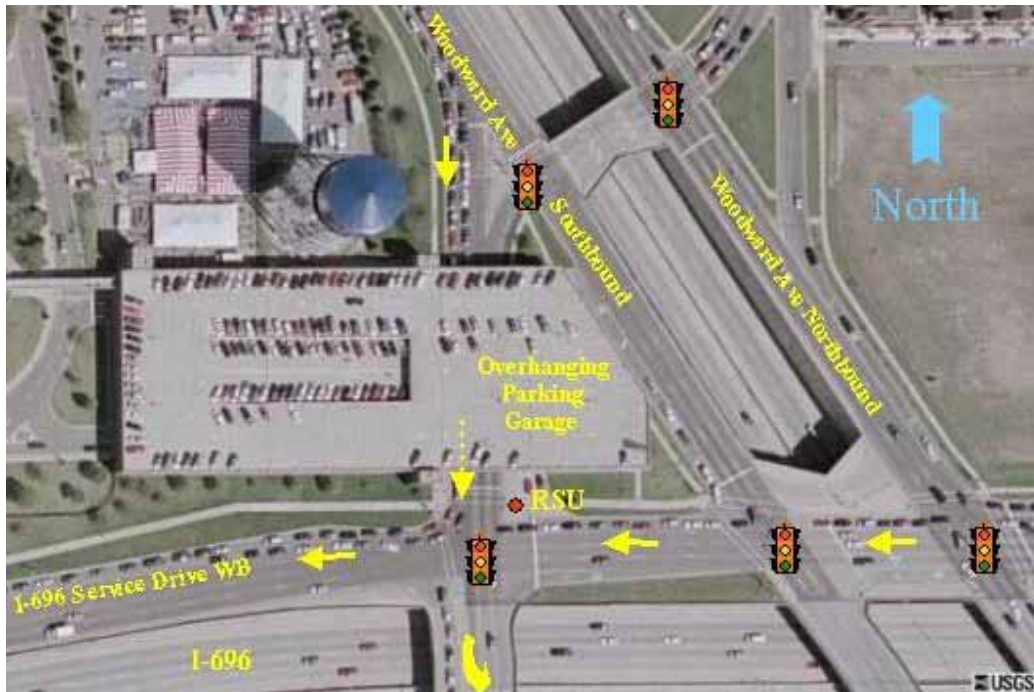
Figure 21. Woodward/I-696 Service Drive Intersection

This intersection has four lanes in the southbound direction and five lanes in the westbound direction, and both directions include a left turn lane (Figure 21). There is medium to heavy traffic during the day. The traffic from southbound Woodward Avenue branches off, passing under a large overhanging parking garage before reaching the traffic signal on the I-696 service drive where the RSU is located. In addition to the parking structure, there are numerous other features that might impact communications, including a water tower, below-surface-level freeways along both test roads, and a number of concrete overpasses.

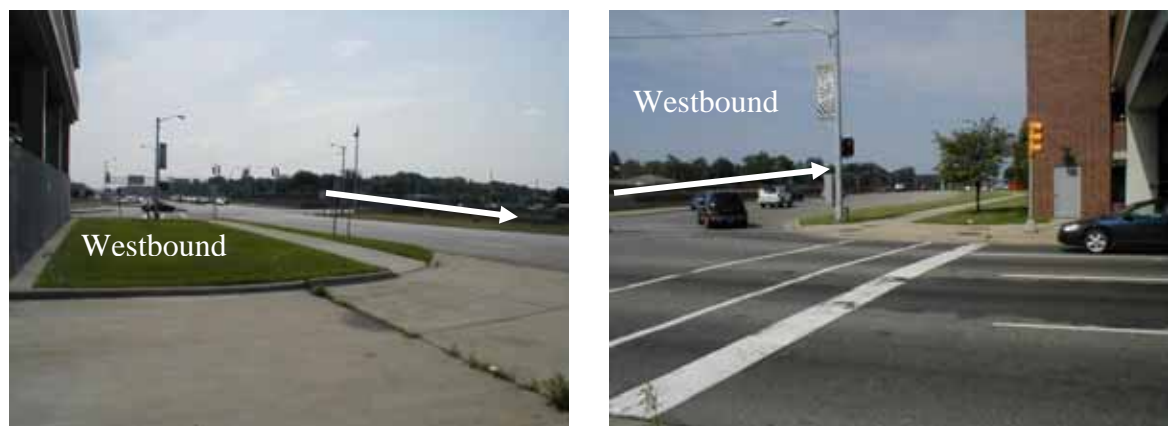
Figure 23. Views and CTK Plot of the I-696 Service Drive Test Route

For westbound I-696 Service Drive (Figures 22 and 23), packets were initially blocked by heavy traffic at a significant distance from the RSU. The cumulative packet reception rate as the vehicle approached the intersection from 250m was 85 percent, and the rate from 100m was 100 percent.

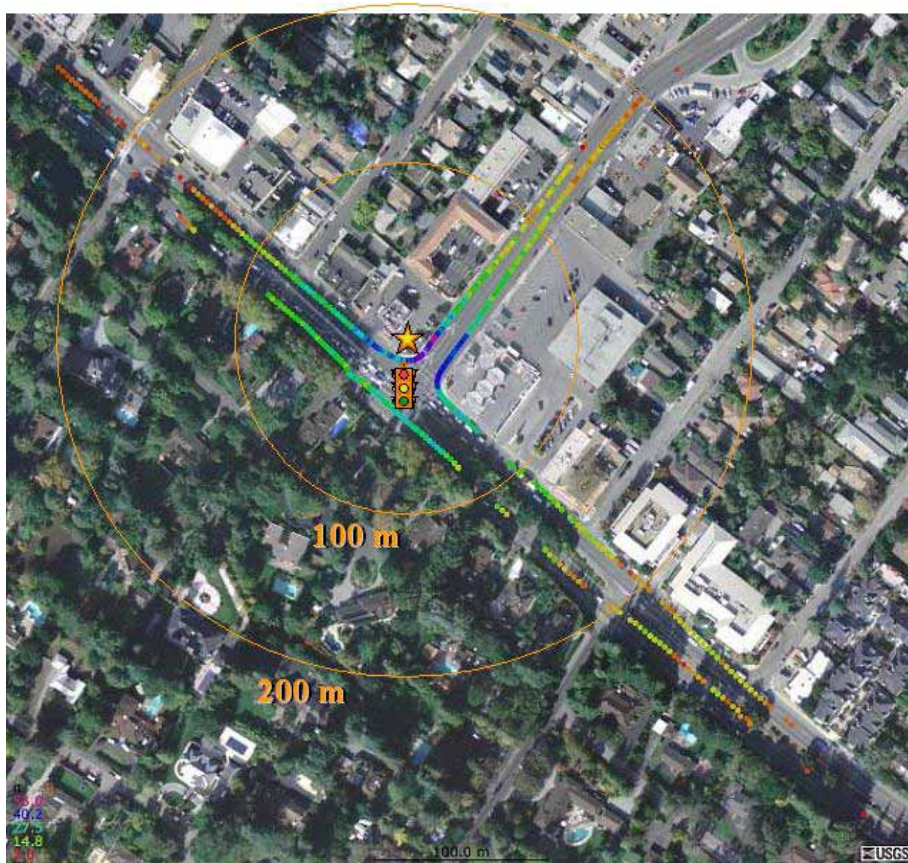
Figure 25. RSSI Plot for El Camino Real/5th at 100% Power (20 dBm)

The test car traveled westbound on 5th, right-turned onto El Camino and headed north. It turned back at approximately 400m away from the RSU. It went past 5th and continued along southbound El Camino. Then it turned back again at about 400m away and returned to the intersection. It right-turned onto 5th and turned back at about 200m away. In the 100 percent power test, the reception is shown in Figure 25. There were occasional dropped GPS signals and packets due to trees and no line-of-sight.

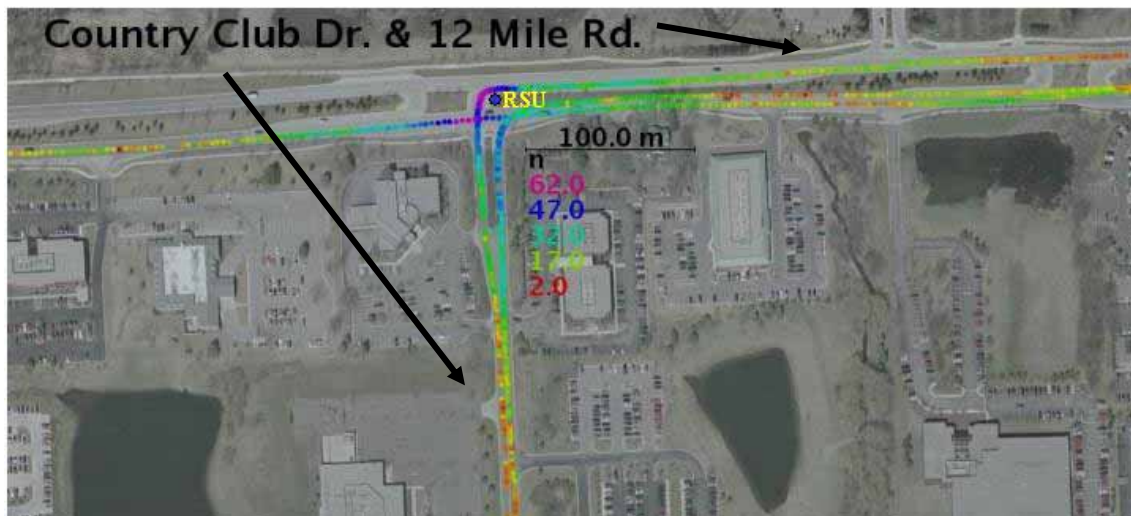
Figure 30. RSSI Plot for the Country Club/12 Mile Intersection

The test vehicle first traveled eastbound on 12 Mile Road straight past the RSU (Figure 30). A few packets were lost at around 200 m on either side of the RSU, possibly due to blockages from trees.

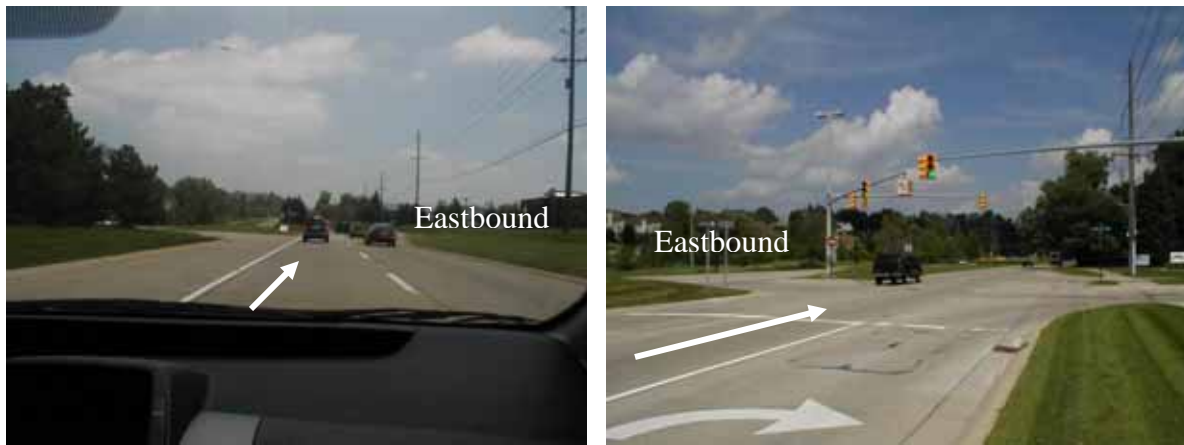
Figure 31. Views and CTK Plot for Eastbound 12 Mile Test Run

Next, the test vehicle U-turned and headed westbound on 12 Mile Road back toward the RSU (Figure 31). The vehicle turned southbound onto Country Club Drive and passed the RSU. Packets were lost going southbound while moving away from RSU due to blockages from trees. The test vehicle then turned around and headed northbound on Country Club Drive, turning right at the intersection past the RSU onto eastbound 12 Mile Road. A few packets are lost going both north and east due to blockages from trees (Figure 32).

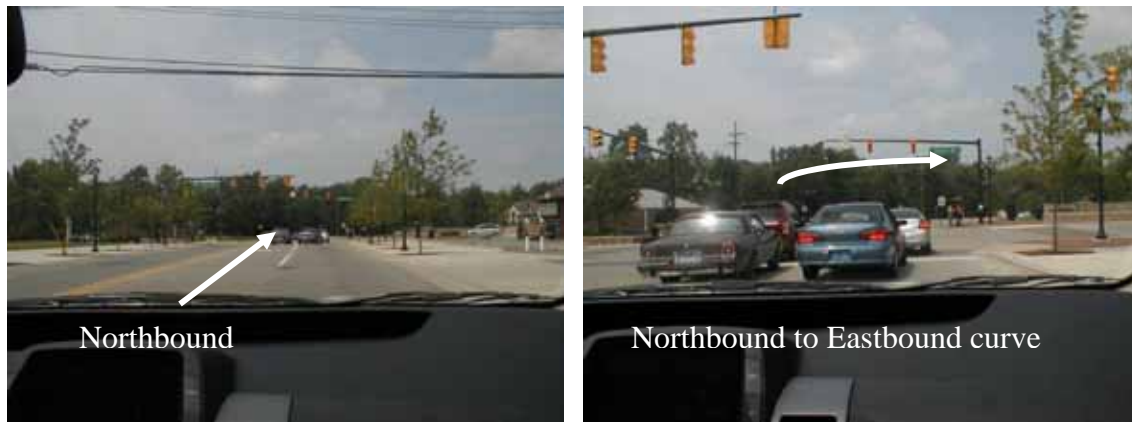
Figure 34. Views and CTK Plot for the Southbound Squirrel Test Run

Traveling northbound on Squirrel Road, 100 percent of packets were received starting at about 275 m since there is clear LOS in this direction on Squirrel Road (Figure 34). Packets were eventually lost due to blockage of terrain alongside the curving roadway on the south side of Squirrel Road. Packet reception ended at a distance of approximately 130m with line-of-sight blocked.

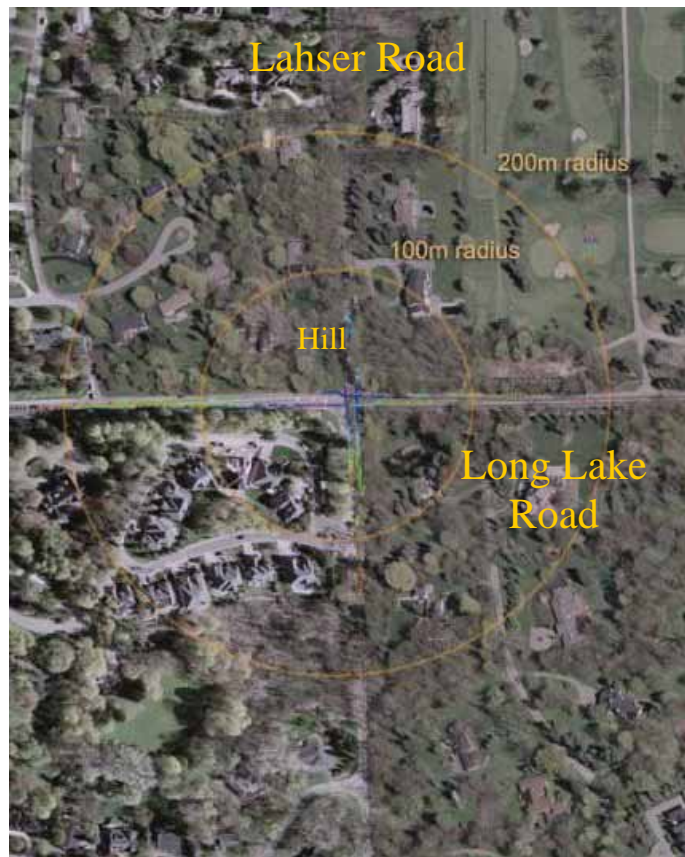
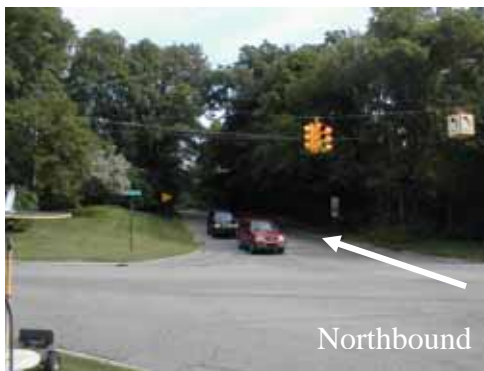
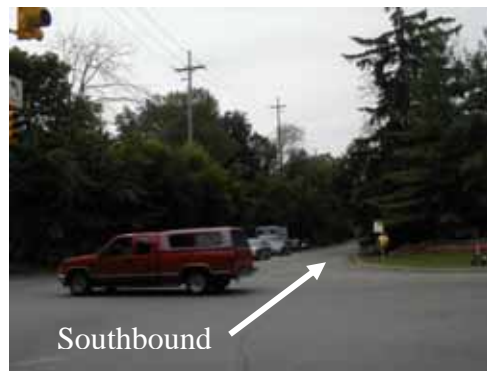
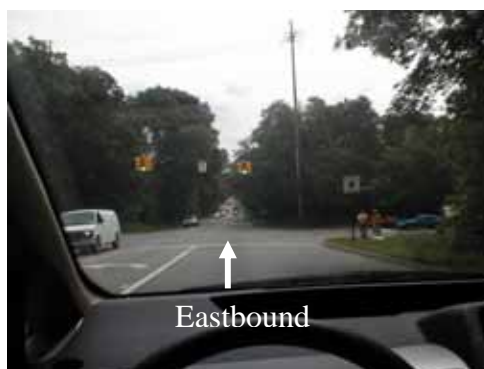
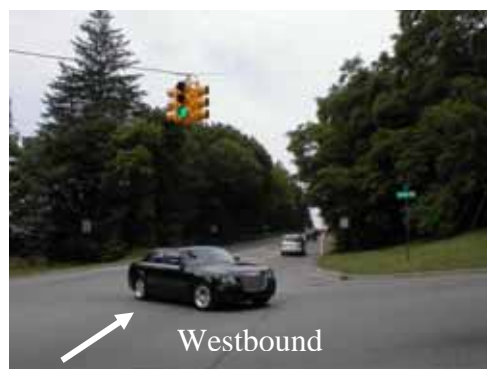
Figure 40. RSSI Plot and Views for the Long Lake/Lahser Test Route

The intersection has two lanes of traffic in the east and westbound directions that have a steady amount of residential (non-commercial) traffic during the daytime hours. The north and southbound directions on Lahser Road have only one lane of traffic in each direction, and slower, sparser traffic than Long Lake. Trees encircle the intersection and block line-of-sight in at least one -- if not all -- directions depending upon the position of the RSU. The RSU was placed on the southeastern corner for safety reasons. Northbound and eastbound traffic was nearly atop the RSU by the time foliage permitted line-of-sight (Figure 40). In the southbound direction, a sharp decline hill prevents line-of-sight to even the traffic light until nearly upon the light. Lost GPS (due to tree cover) does not provide an accurate distance-to-RSU, but line-of-sight to the traffic light becomes available near 150 meters from the intersection center. In all directions of travel, ground level foliage prevented line-of-sight communication (Figures 40 and 41).

For this intersection, the two test personnel stationed at the RSU attempted to identify the first moment that the test vehicle was seen approaching the RSU, and the last moment it was seen driving away from it. These moments in time were linked with the corresponding packet number and identified in the CTK plots of Figure 41 as the estimated periods during which line-of-sight exists between the RSU and the test vehicle.

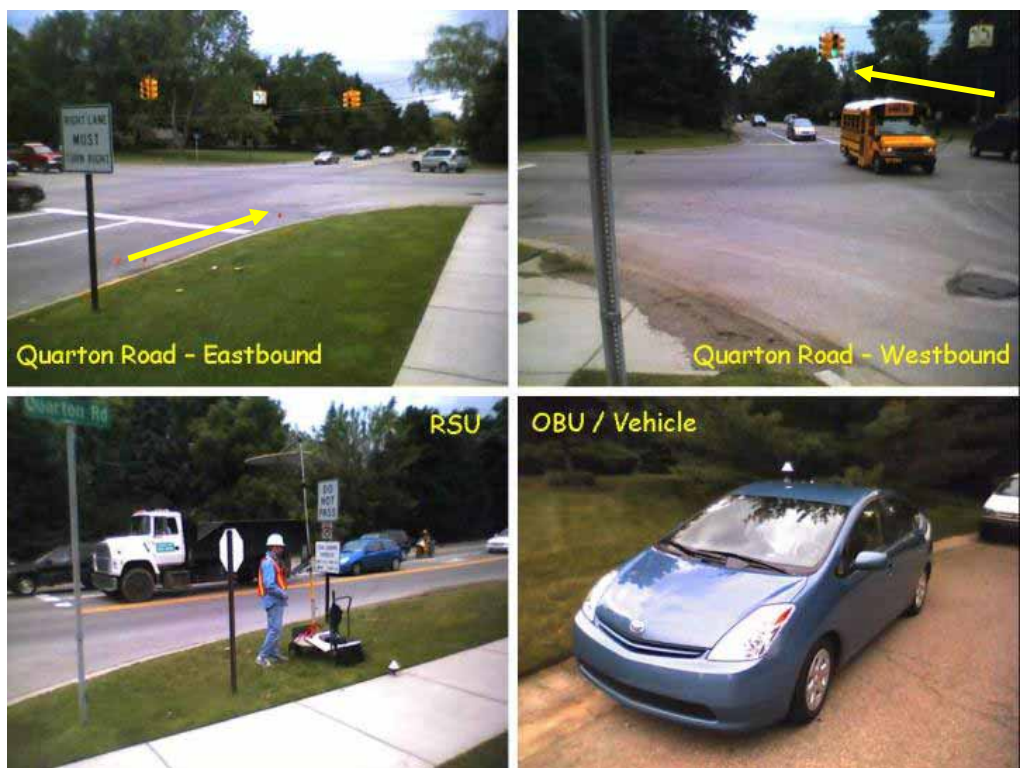
Figure 43. Views and CTK Plots for the Quarton Test Routes

Proceeding eastbound, no packets were lost as the test vehicle approached the intersection from within 100 m (Figure 43). Approximately 50m east of the RSU, the GPS signal was temporarily lost due to an obstruction from trees along the road; however, radio reception was not affected in this region. Driving westbound, 2 packets were lost with the test vehicle within ~100m of the intersection in this case. Owing to the slightly different line of sight to the vehicle in the westbound lane, the range of radio reception was slightly different than the prior data, and there were no losses of GPS signal coverage.

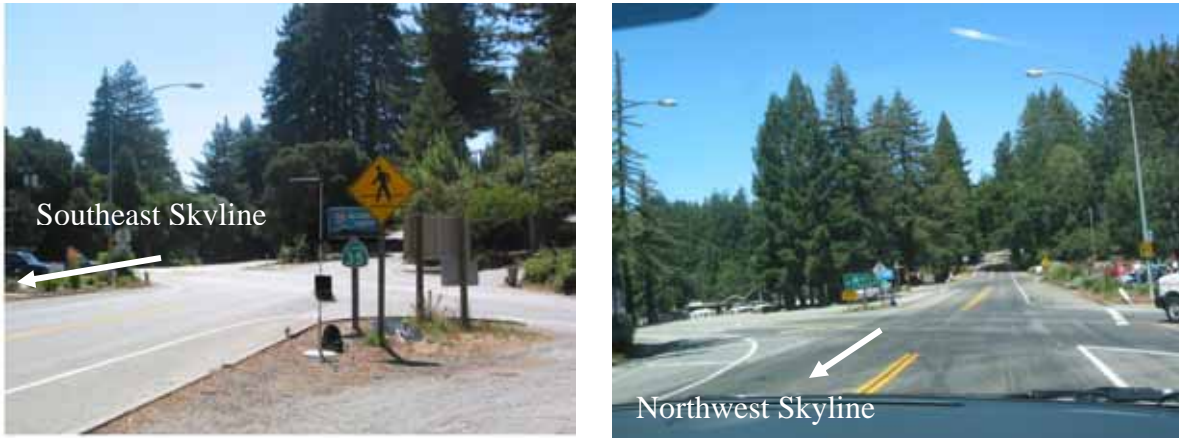
Figure 45. Views and CTK Plot for the Skyline Test Run

The car started from the RSU and went southeast on Skyline (Figure 45). It turned around, went through the intersection, and turned around again and returned to the RSU. Poor GPS signals and dropped packets were recorded along the test route when the car was more than 70m away from the intersection due to heavy foliage blockage to GPS satellites and no line-of-sight from RSU to OBU at up-hills and curves.

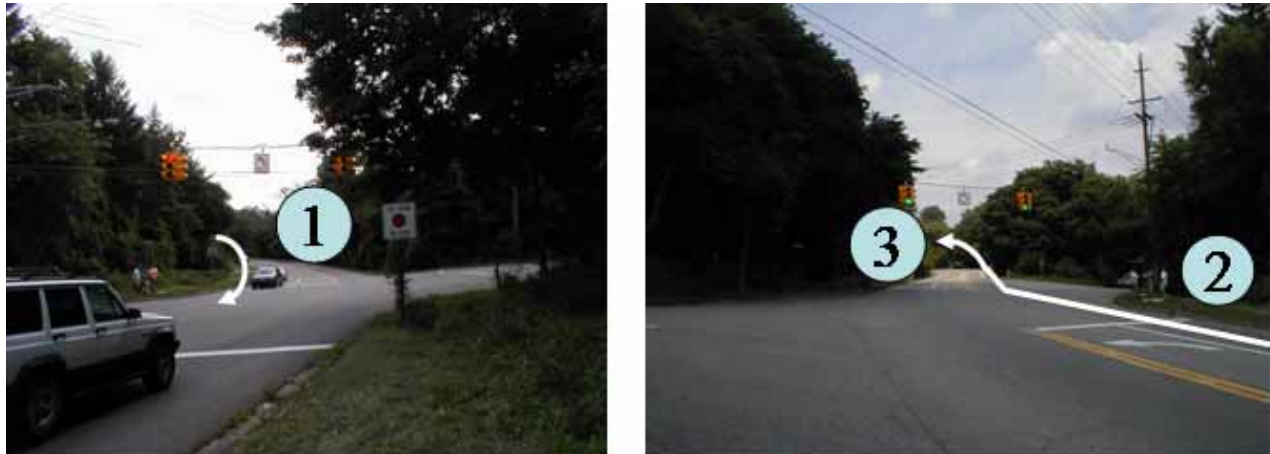
Figure 51. Views and CTK Plot for the Westbound Long Lake Test Run

For westbound Long Lake, line of sight was initially blocked by terrain and foliage along the curving roadway before packet reception becomes 100 percent as the vehicle approached from ~100 m (Figure 51, caption 1). The test vehicle stopped at the traffic signal with 100 percent packet reception (2). Intermittent packet reception and GPS outage occurred as the vehicle traveled along the curving roadway with foliage and terrain blockage (3).

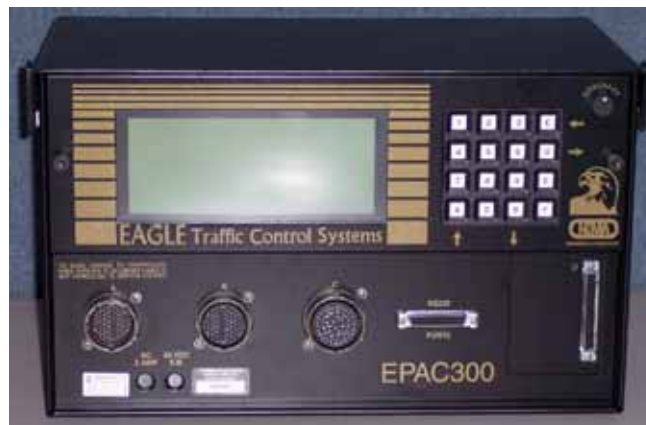
Figure 55. EPAC M30

The controller used was an Eagle EPAC300 M30. It is shown in Figure 55.

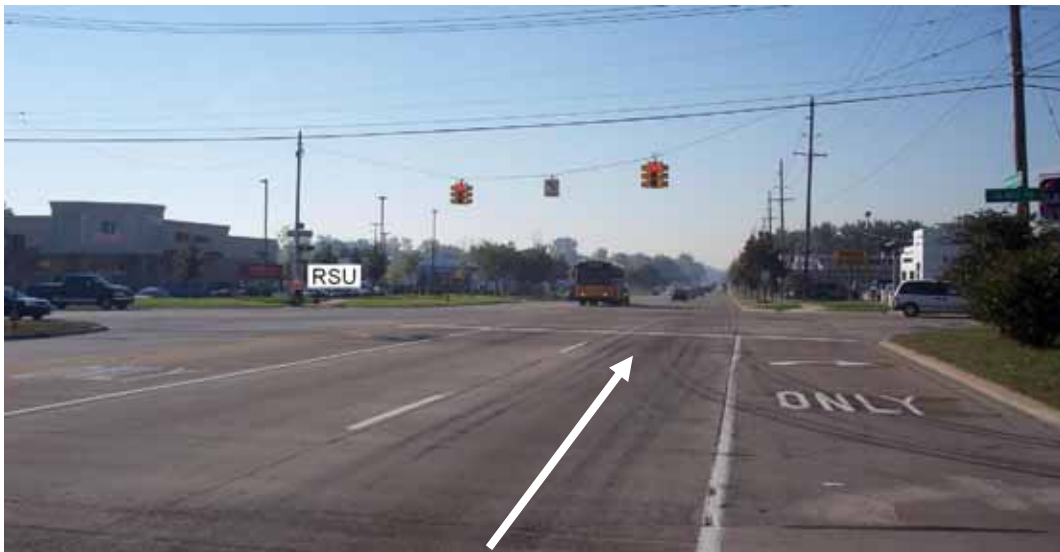
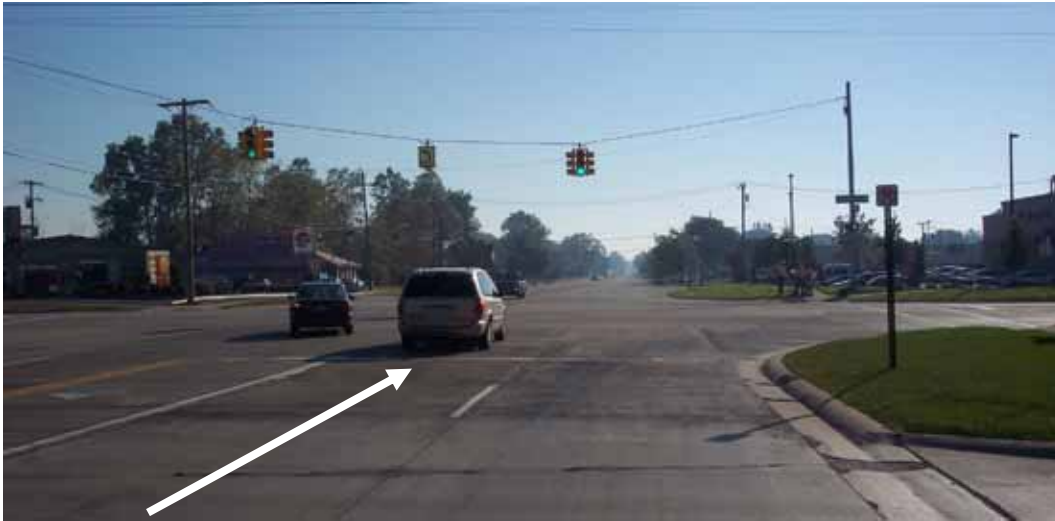
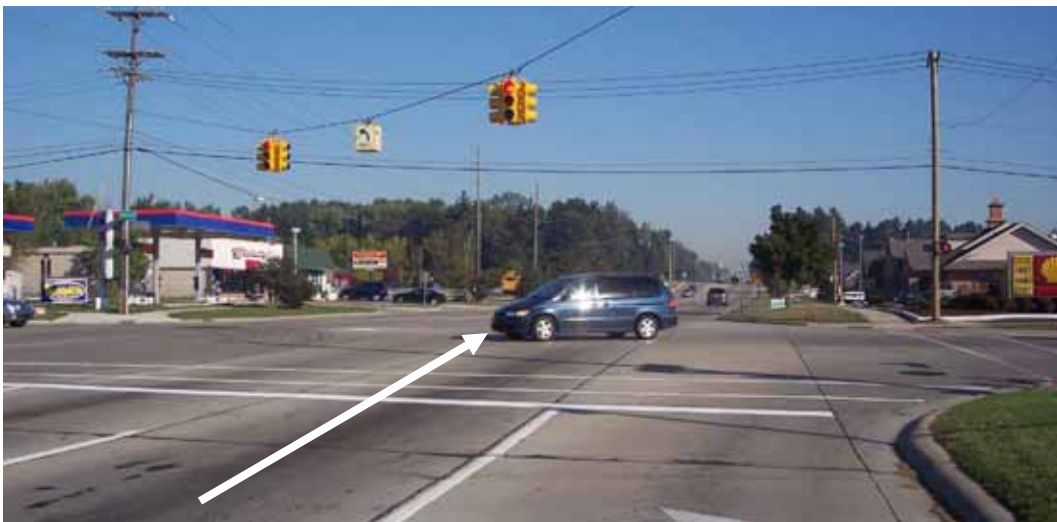
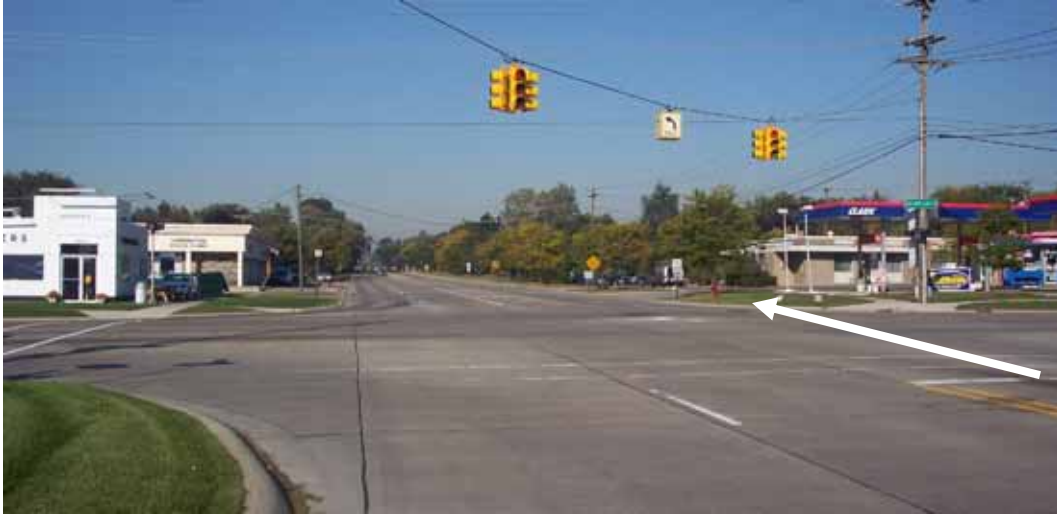
Figure 56. Orchard Lake Road – Southbound Direction

Figures 56 through 59 show the intersection from four different directions.

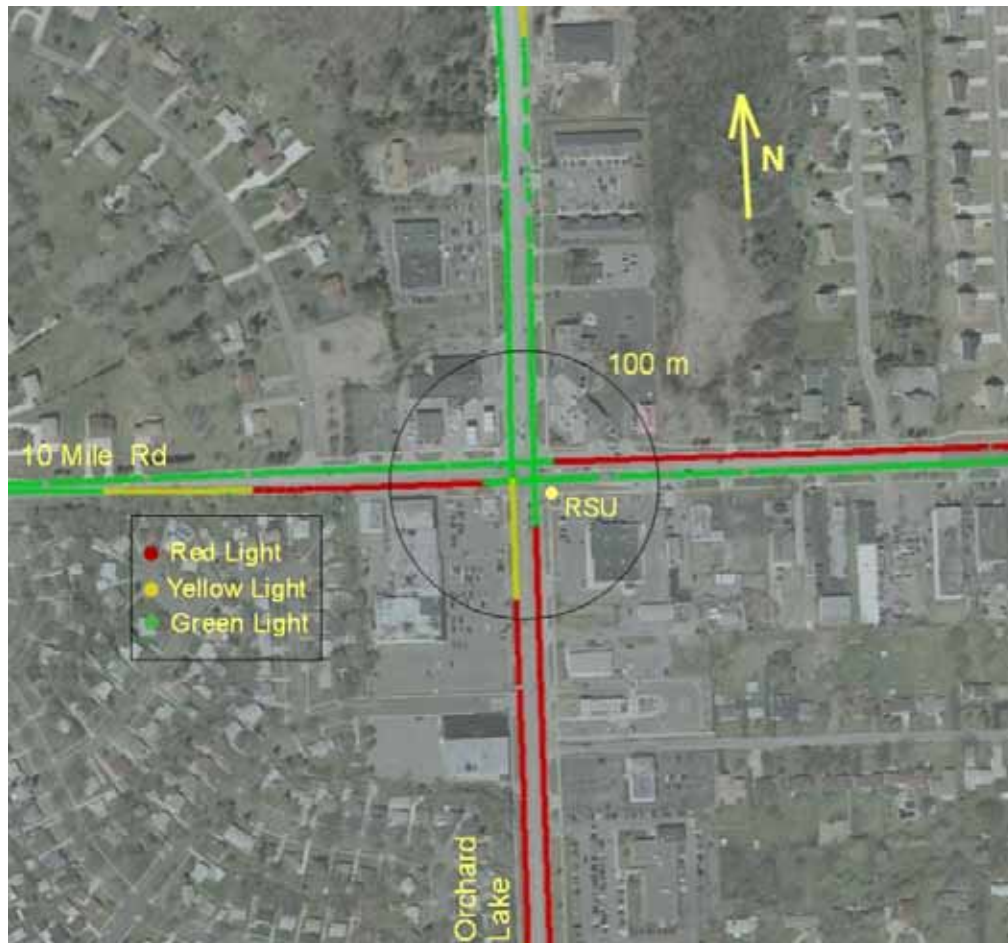
Figure 77. Orchard Lake & 10 Mile Rd intersection. Current Signal State as Received by the OBU From the RSU

Finally, the signal state was overlaid on top of the aerial photograph of the intersection in Figure 77 to give the reader a better view of “what was received” and “when it was received” from the RSU as the OBU drives through the intersection.

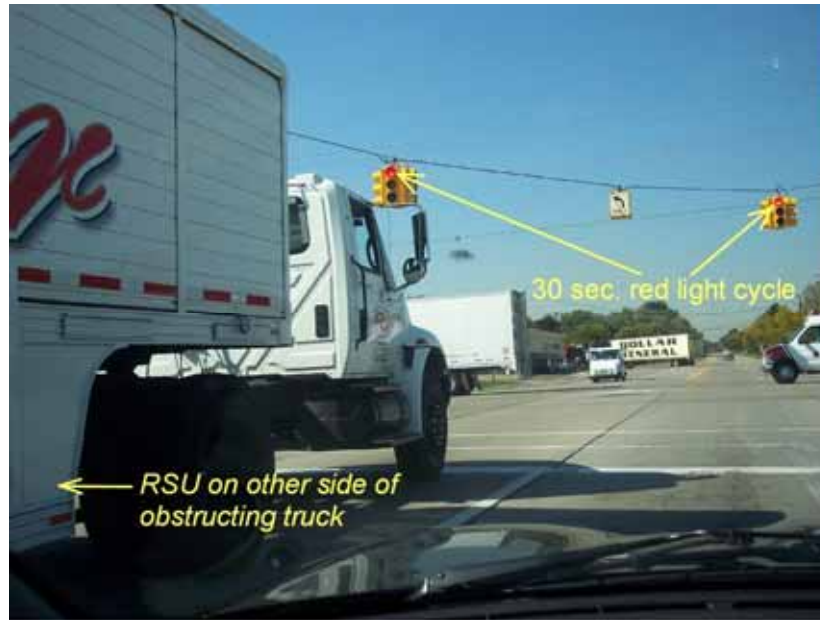
Figure 80. RSU to the Left of Truck Being Obstructed From OBU

Figure 79 summarizes the data collected at the 12 dBm power level setting for a westbound run. Again, the maximum range of communication dropped from 550 m (full power setting), see Figure 61, to approximately 375 m. Note the sharp RSSI drop at 30 seconds in the time line as a truck blocked the direct line of sight between the OBU and the RSU for a full 30-second period. Both the truck and the OBU vehicle were stopped at a red light. No packets were lost during that obstruction.
